**Flood Control Project Maintenance
Levee Inspections**
LMA District Cover Sheet
Spring 2017 Levee Inspection Results

Butte County Department of Public Works

Spring 2017 Levee Inspection Results

Waterway			Bank	Unit Miles
Unit No. 01 Mud Creek			Right	6.80
	Spring (March - May)	Summer (June - August)	(September - November) Fall	Winter (December - February)
Unit Maintenance Rating (Fall Only)				
Date of Inspection	4/20/2017 - 4/20/2017			
DWR Inspector	Bob Duffey			
Accompanied By	Shawn Bates Butte County

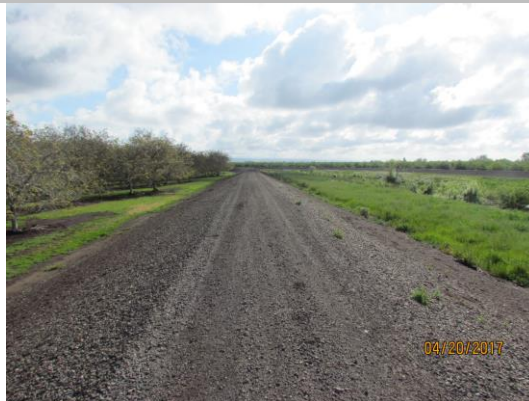
Photo 1 of 1 : SP_2017_NA0003_64_57_20170426_00067.jpg

LM Start	1.05	Rating **	A	Issue No.	57
LM End	1.05	Issue Type +	Ma	Location *	LS
Category	Earthen Levee			GPS Latitude/Longitude	
				Start	End
Item	Vegetation			39.739553 °	39.739553 °
				-121.931025 °	-121.931025 °
DWR ID	DWR_NA0003_01_s_2017_57				
Comment Code					
V1 : Control annual grass and weeds on the levee slopes and easements.					
Inspector Comment

View of no vegetation on both slopes.

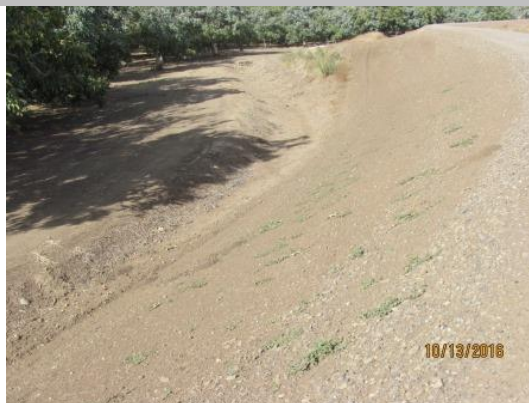
Photo 1 of 1 : SP_2017_NA0003_64_46_20170315_00026.jpg

LM Start	1.19	Rating **	M	Issue No.	46
LM End	1.25	Issue Type +	En	Location *	LS
Category	Earthen Levee			GPS Latitude/Longitude	
				Start	End
Item	Encroachments			39.740082 °	39.740697 °
				-121.928383 °	-121.927844 °
DWR ID	DWR_NA0003_01_f_2016_46				
Comment Code					
DT : Ditch					
Inspector Comment

View of a ditch along the toe.

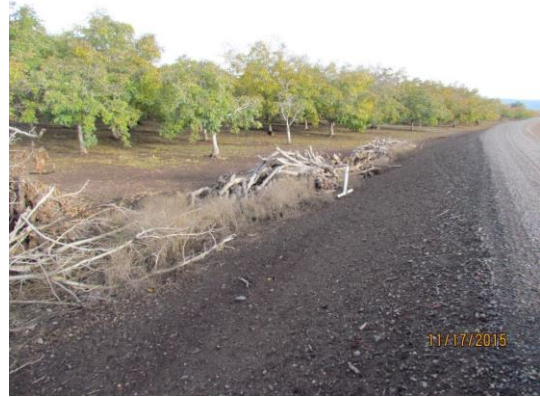
Photo 1 of 1 : SP_2017_NA0003_64_15_20170315_00003.jpg

LM Start	1.69	Rating **	M	Issue No.	15
LM End	1.69	Issue Type +	En	Location *	LS
Category	Earthen Levee			GPS Latitude/Longitude	
				Start	End
Item	Encroachments			39.745718 °	39.745718 °
				-121.923124 °	-121.923124 °
DWR ID	DWR_NA0003_01_s_2014_15				
Comment Code					
FW : Firewood					
Inspector Comment					
Remove the firewood from the landside toe

View of the firewood along the landside toe.

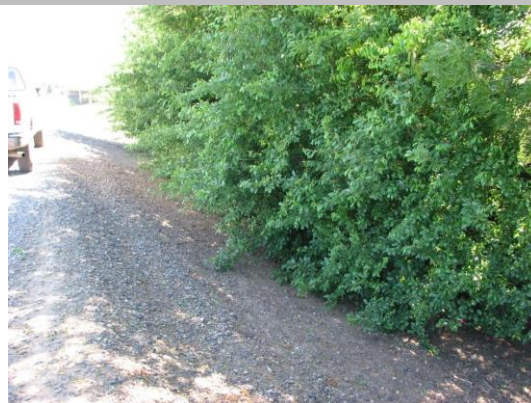
Photo 1 of 1 : SP_2017_NA0003_64_42_20170315_00025.jpg

LM Start	1.97	Rating **	M	Issue No.	42
LM End	1.99	Issue Type +	En	Location *	LS
Category	Earthen Levee			GPS Latitude/Longitude	
				Start	End
Item	Vegetation			39.747946 °	39.748170 °
				-121.918881 °	-121.918778 °
DWR ID	DWR_NA0003_01_s_2016_42				
Comment Code					
V6 : Landscaping					
Inspector Comment					
Landscaping vegetation obscuring visibility on the landside toe.

View of the overgrown trees at the landside levee toe.

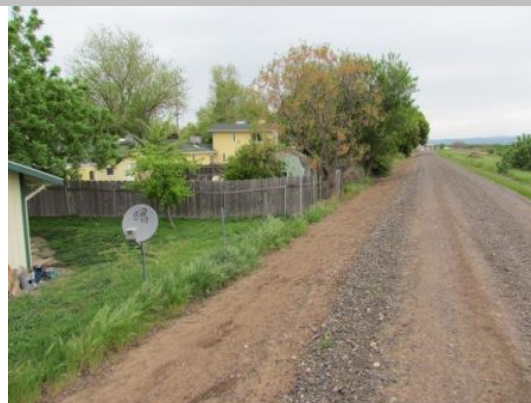
Photo 1 of 1 : SP_2017_NA0003_64_3_20170315_00002.jpg

LM Start	2.00	Rating **	M	Issue No.	3
LM End	2.04	Issue Type +	En	Location *	LS
Category	Earthen Levee			GPS Latitude/Longitude	
				Start	End
Item	Encroachments			39.748330 °	39.748867 °
				-121.918685 °	-121.918533 °
DWR ID	DWR_NA0003_01_s_2012_3				
Comment Code					
FE : Fence					
Inspector Comment

View of the fences along the landside toe.

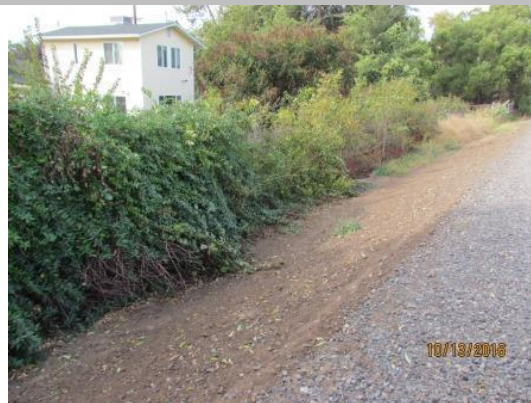
Photo 1 of 1 : SP_2017_NA0003_64_48_20170315_00027.jpg

LM Start	2.03	Rating **	M	Issue No.	48
LM End	2.11	Issue Type +	En	Location *	LS
Category	Earthen Levee			GPS Latitude/Longitude	
				Start	End
Item	Vegetation			39.748784 °	39.749872 °
				-121.918597 °	-121.918296 °
DWR ID	DWR_NA0003_01_f_2016_48				
Comment Code					
V6 : Landscaping					
Inspector Comment

View of landscaping vegetation blocking visibility.

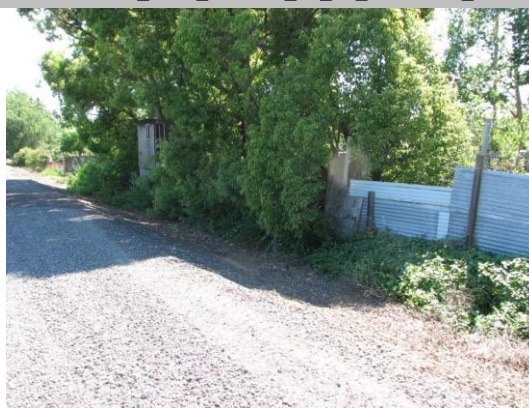
Photo 1 of 1 : SP_2017_NA0003_64_40_20170315_00022.jpg

LM Start	2.06	Rating **	U	Issue No.	40
LM End	2.08	Issue Type +	En	Location *	LS
Category	Earthen Levee			GPS Latitude/Longitude	
				Start	End
Item	Encroachments			39.749145 °	39.749461 °
				-121.918506 °	-121.918425 °
DWR ID	DWR_NA0003_01_s_2016_40				
Comment Code					
FE : Fence					
Inspector Comment					
Piecemeal corrugated fencing with vegetation completely obscuring landside toe. Small fort included along fencing.

View of a metal fence and treehouse obstructing visibility and access.

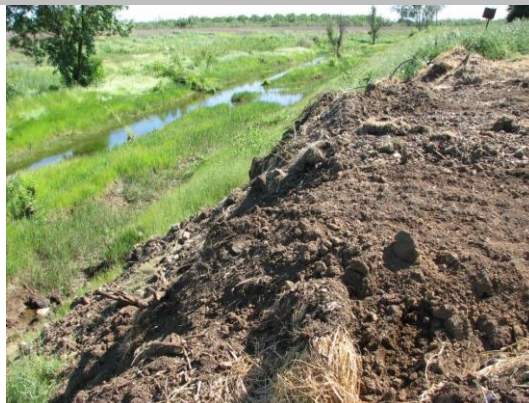
Photo 2 of 2 : SP_2017_NA0003_64_41_20170315_00024.jpg

LM Start	2.06	Rating **	U	Issue No.	41 (cont)	
LM End	2.06	Issue Type +	En	Location *	WS	
Category	Earthen Levee			GPS Latitude/Longitude		
				Start		End
Item	Encroachments			39.749149 °		39.749149 °
				-121.918510 °		-121.918510 °
DWR ID	DWR_NA0003_01_s_2016_41					
Comment Code						
DE : Debris						
Inspector Comment						
Homeowner is dragging soil and debris across levee and dumping on waterside terrace.

04/25/2016: Soil and debris dragged across levee from L/S to W/S and pushed into channel.

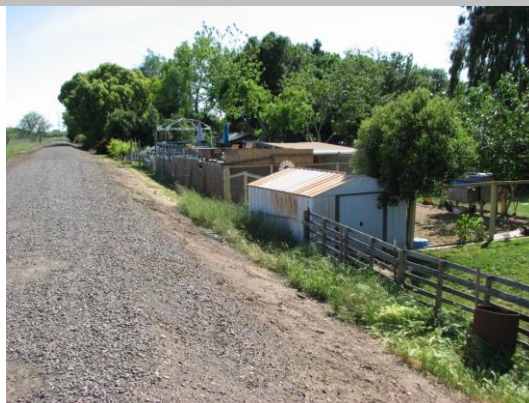
Photo 1 of 1 : SP_2017_NA0003_64_24_20170315_00007.jpg

LM Start	2.10	Rating **	U	Issue No.	24
LM End	2.10	Issue Type +	En	Location *	LS
Category	Earthen Levee			GPS Latitude/Longitude	
				Start	End
Item	Encroachments			39.749732 °	39.749732 °
				-121.918270 °	-121.918270 °
DWR ID	DWR_NA0003_01_s_2012_24				
Comment Code					
BU : Building					
Inspector Comment					
Shed and plank fencing blocking visibility.

View of a metal shed and fence along the landside toe.

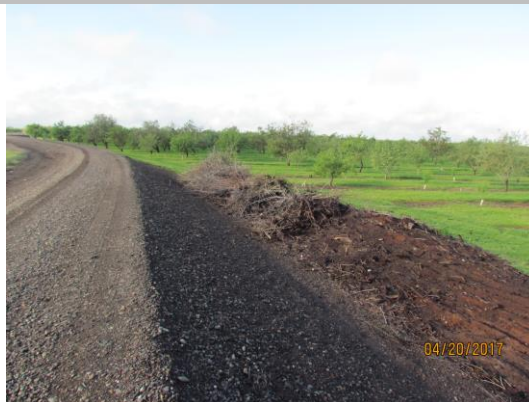
Photo 1 of 2 : SP_2017_NA0003_64_49_20170426_00065.jpg

LM Start	2.59	Rating **	M	Issue No.	49
LM End	2.59	Issue Type +	En	Location *	LS
Category	Earthen Levee			GPS Latitude/Longitude	
				Start	End
Item	Encroachments			39.755930 °	39.755930 °
				-121.914829 °	-121.914829 °
DWR ID	DWR_NA0003_01_f_2016_49				
Comment Code					
PR : Prunings					
Inspector Comment					
Remove prunings from the landside toe.

View of the prunings along the landside toe.

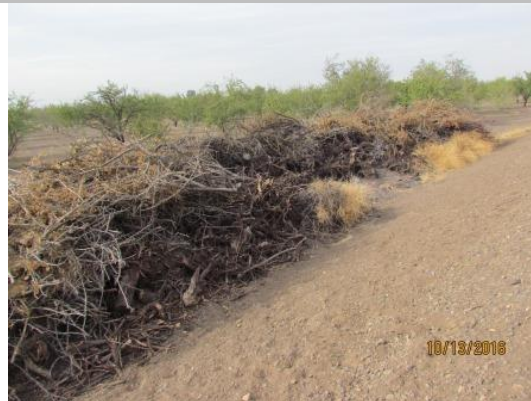
Photo 2 of 2 : SP_2017_NA0003_64_49_20170315_00028.jpg

LM Start	2.59	Rating **	M	Issue No.	49 (cont)	
LM End	2.59	Issue Type +	En	Location *	LS	
Category	Earthen Levee			GPS Latitude/Longitude		
				Start		End
Item	Encroachments			39.755930 °		39.755930 °
				-121.914829 °		-121.914829 °
DWR ID	DWR_NA0003_01_f_2016_49					
Comment Code						
PR : Prunings						
Inspector Comment						
Remove prunings from the landside toe.

View of the prunings along the landside toe.

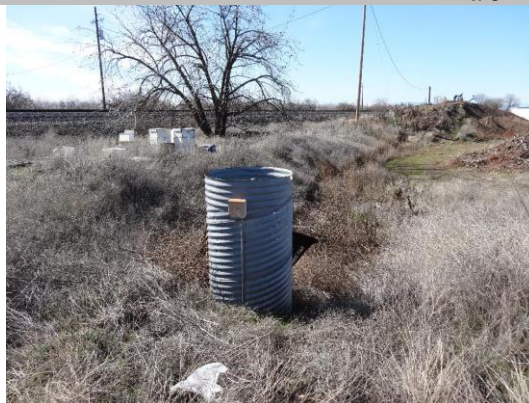
Photo 2 of 3 : UCIP_SP_2017_30291_55699.jpg

Comment Code						
Inspector Comment						
FS_ID:30291						
DS_ID:19230						
EP_NO: 16633						
Repair Type: Non-Urgent						
Crossing Status: Indicator Found						
UCIP Comments: A concrete water control box on landside shoulder. It needs confirmation and more info from LMA and/or DWR Inspector.						
FIELD_STRUCT_DESC: A 2-inch diameter storm water discharge pipeline through the right bank and landward levee toe of Mud Creek.						
Used a 2-inch coated & wrapped steel pipe. Submerged pump in 36 inch dia CMP casing approx 10 ft from landside toe. Drainage ditch, up to 4 ft wide, runs perpendicular to levee alignment starting at CMP riser and running away from levee. (App. No. 16633)						
FS Date: 2/20/2014

LS view: CMP riser on levee toe and drainage ditch perpendicular to the levee.

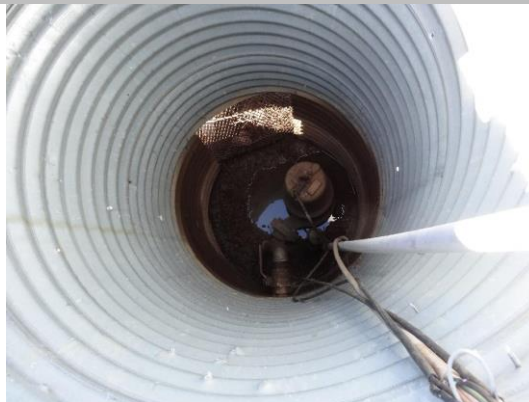
Photo 3 of 3 : UCIP_SP_2017_30291_55698.jpg

LS view: inside view of CMP riser. Pipe, gate valve, air vent, and submersible pump in the riser.

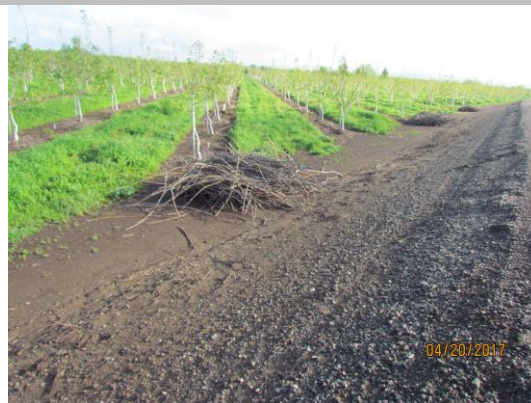
Photo 1 of 1 : SP_2017_NA0003_64_56_20170426_00066.jpg

LM Start	2.74	Rating **	M	Issue No.	56
LM End	2.74	Issue Type +	En	Location *	LS
Category	Earthen Levee			GPS Latitude/Longitude	
				Start	End
Item	Encroachments			39.757763 °	39.757763 °
				-121.913320 °	-121.913320 °
DWR ID	DWR_NA0003_01_s _ 2017_56				
Comment Code					
PR : Prunings					
Inspector Comment

View of the prunings along the landside toe.

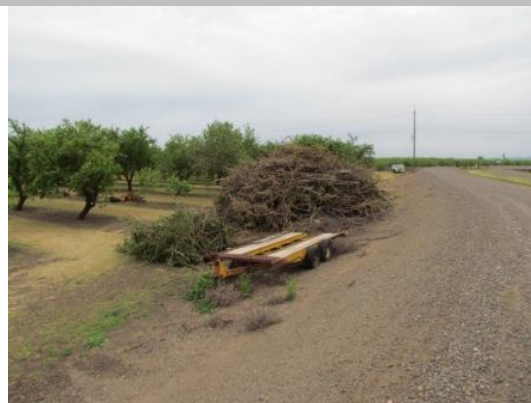
Photo 1 of 1 : SP_2017_NA0003_64_1_20170315_00001.jpg

LM Start	2.93	Rating **	M	Issue No.	1
LM End	2.93	Issue Type +	En	Location *	LS
Category	Earthen Levee			GPS Latitude/Longitude	
				Start	End
Item	Encroachments			39.759755 °	39.759755 °
				-121.911160 °	-121.911160 °
DWR ID	DWR_NA0003_01_s _ 2012_1				
Comment Code					
PR : Prunings					
Inspector Comment					
Remove the prunings from the landside slope.

View of the pruning pile along the landside toe.

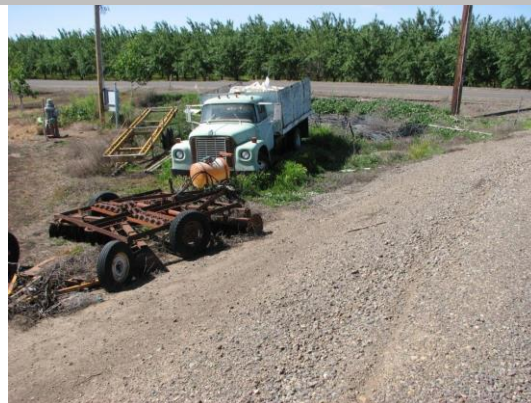
Photo 1 of 1 : SP_2017_NA0003_64_39_20170315_00021.jpg

LM Start	2.98	Rating **	M	Issue No.	39
LM End	2.98	Issue Type +	En	Location *	LS
Category	Earthen Levee			GPS Latitude/Longitude	
				Start	End
Item	Encroachments			39.760539 °	39.760539 °
				-121.911376 °	-121.911376 °
DWR ID	DWR_NA0003_01_s _ 2016_39				
Comment Code					
AV : Abandoned vehicles					
Inspector Comment					
Truck and farm equipment blocking landside toe.

View of equipment and vehicles along the landside toe.

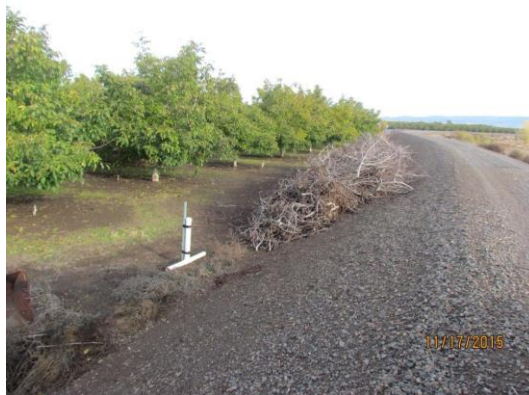
Photo 2 of 2 : SP_2017_NA0003_64_31_20170315_00014.jpg

LM Start	3.15	Rating **	M	Issue No.	31 (cont)	
LM End	3.15	Issue Type +	En	Location *	LS	
Category	Earthen Levee			GPS Latitude/Longitude		
				Start		End
Item	Encroachments			39.762565 °		39.762565 °
				-121.909873 °		-121.909873 °
DWR ID	DWR_NA0003_01_s_2015_31					
Comment Code						
PR : Prunings						
Inspector Comment						
Remove the prunings from the landside slope.

View of the prunings and bait station along the landside slope.

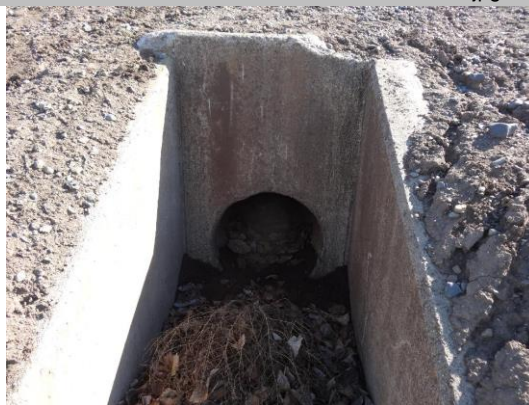
Photo 2 of 3 : UCIP_SP_2017_30310_55740.jpg

LS view: U type concrete headwall and CMP on levee slope.

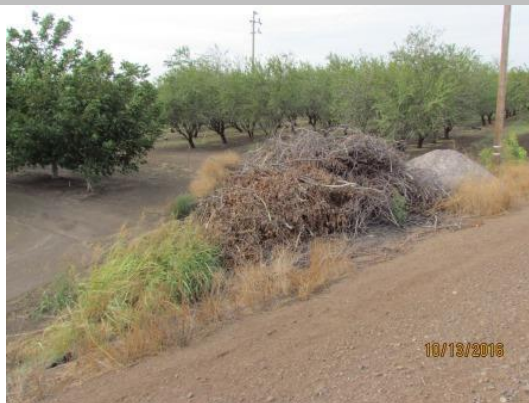
Photo 1 of 1 : SP_2017_NA0003_64_50_20170315_00029.jpg

LM Start	3.70	Rating **	M	Issue No.	50
LM End	3.70	Issue Type +	En	Location *	LS
Category	Earthen Levee			GPS Latitude/Longitude	
				Start	End
Item	Encroachments			39.767920 °	39.767920 °
				-121.902520 °	-121.902520 °
DWR ID	DWR_NA0003_01_f_2016_50				
Comment Code					
PR : Prunings					
Inspector Comment					
Remove prunings from the landside toe.

View of the prunings along the landside toe.

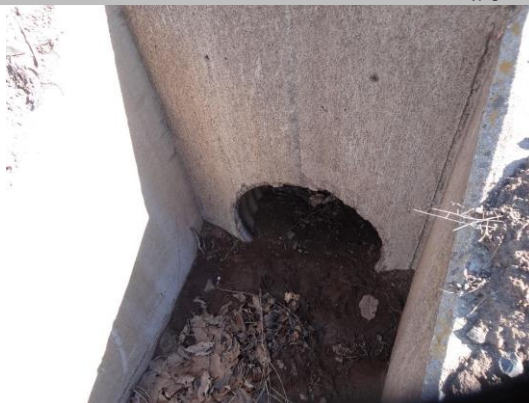
Photo 2 of 2 : UCIP_SP_2017_30311_55742.jpg

LM Start	3.97	Rating **	M	Issue No.	65 (cont)	
LM End	3.97	Issue Type +	Ma	Location *	LS	
Category	Supplemental			GPS Latitude/Longitude		
				Start		End
Item	DWR UCIP LMA Responsibility			39.771293 °		39.771293 °
				-121.900247 °		-121.900247 °
DWR ID						
Comment Code						
Inspector Comment						
FS_ID:30311 DS_ID:19219 EP_NO: N/A Repair Type: Non-Urgent Crossing Status: Found UCIP Comments: Needs cleaning and clearing of debris in both ends of the pipe. FIELD_STRUCT_DESC: 24-inch CM pipe through the levee, 9.0 feet below the crown. Flap gate on the waterward end. Concrete "U" headwalls on both ends. Grouted riprap apron on the landward end. Grouted riprap spillway on the waterward end. O&M Manual Sac 504, May 1965. FS Date: 2/20/2014

LS view: U type concrete headwall and CMP on levee slope.

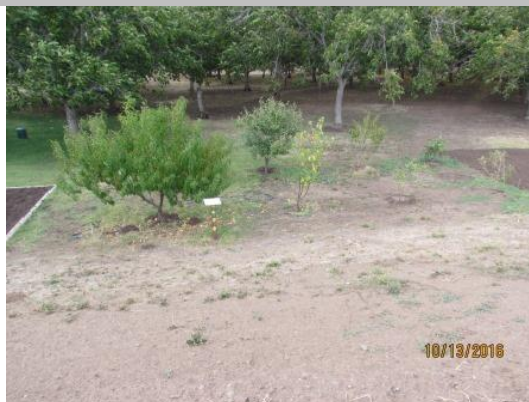
Photo 1 of 1 : SP_2017_NA0003_64_29_20170315_00011.jpg

LM Start	4.01	Rating **	M	Issue No.	29
LM End	4.01	Issue Type +	En	Location *	LS
Category	Earthen Levee			GPS Latitude/Longitude	
				Start	End
Item	Encroachments			39.771732 °	39.771732 °
				-121.899699 °	-121.899699 °
DWR ID	DWR_NA0003_01_f_2014_29				
Comment Code					
CR : Crops					
Inspector Comment					
Fruit trees at the toe of the levee.

View of the fruit trees within 10' of landside levee toe.

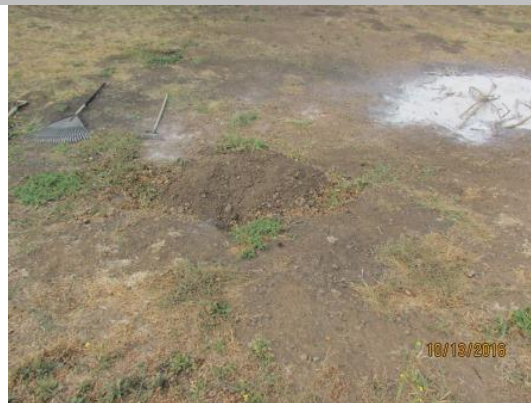
Photo 1 of 1 : SP_2017_NA0003_64_51_20170315_00030.jpg

LM Start	4.03	Rating **	M	Issue No.	51
LM End	4.03	Issue Type +	Ma	Location *	LS
Category	Earthen Levee			GPS Latitude/Longitude	
				Start	End
Item	Animal Control			39.771877 °	39.771877 °
				-121.899441 °	-121.899441 °
DWR ID	DWR_NA0003_01_f_2016_51				
Comment Code					
A1 : Exterminate rodents and backfill and compact or grout burrows.					
Inspector Comment

View of the rodent holes along the landside slope.

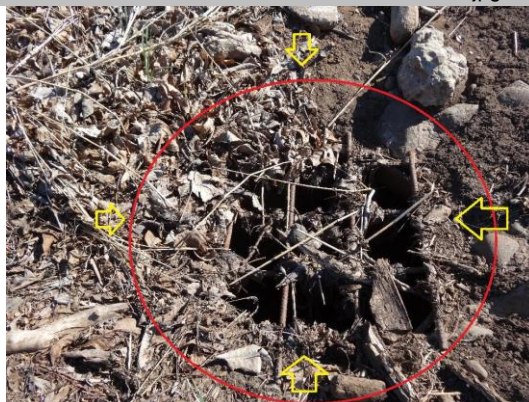
Photo 2 of 2 : UCIP_SP_2017_30388_55890.jpg

LS view: Underground CM standpipe intake with steel grit on levee toe.

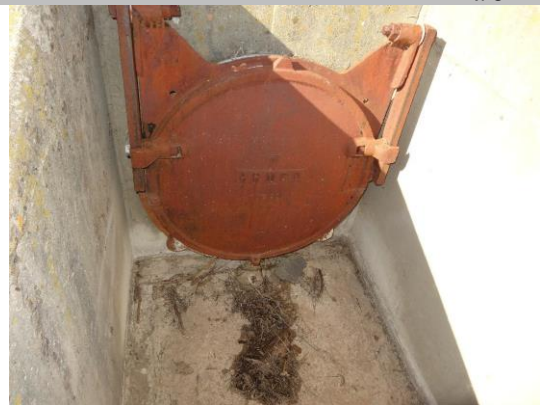
Photo 1 of 3 : UCIP_SP_2017_30327_55768.jpg

WS view: U type concrete headwall, pipe, and flapgate on levee slope.

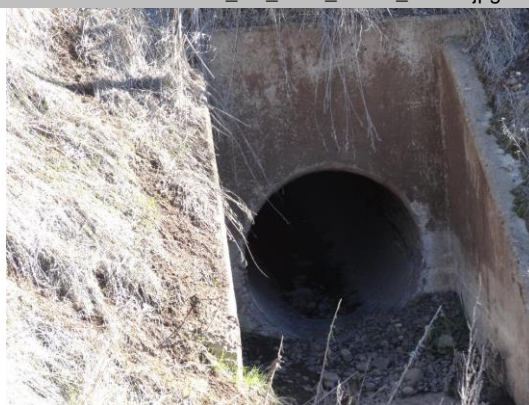
Photo 3 of 3 : UCIP_SP_2017_30327_55766.jpg

LS view: U type concrete headwall and CMP on levee slope.

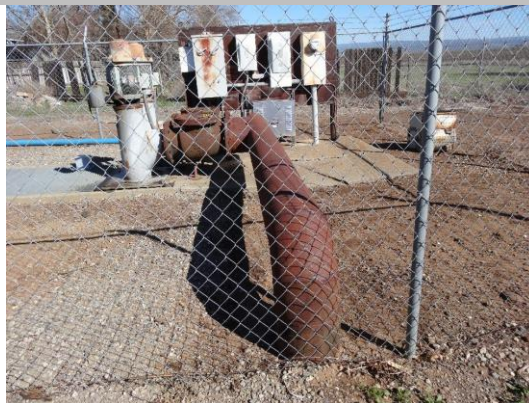
Photo 3 of 3 : UCIP_SP_2017_30368_55859.jpg

LS view: pipe, pumps, power boxes, concrete vault on landside.

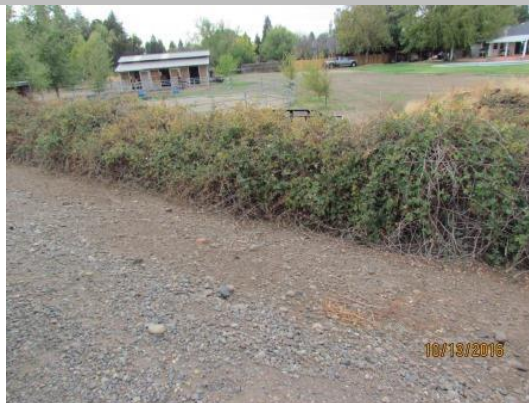
Photo 1 of 1 : SP_2017_NA0003_64_22_20170315_00005.jpg

LM Start	5.96	Rating **	M	Issue No.	22
LM End	5.96	Issue Type +	En	Location *	LS
Category	Earthen Levee			GPS Latitude/Longitude	
				Start	End
Item	Vegetation			39.793116°	39.793116°
				-121.887296°	-121.887296°
DWR ID	DWR_NA0003_01_f_2016_22				
Comment Code					
V6 : Landscaping					
Inspector Comment					
Blackberry bramble

View of the blackberries blocking visibility and access.

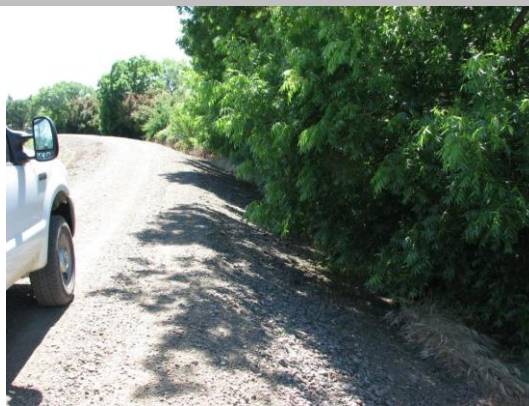
Photo 1 of 1 : SP_2017_NA0003_64_37_20170315_00019.jpg

LM Start	5.98	Rating **	U	Issue No.	37
LM End	6.07	Issue Type +	En	Location *	LS
Category	Earthen Levee			GPS Latitude/Longitude	
				Start	End
Item	Vegetation			39.793411 °	39.794580 °
				-121.887310 °	-121.886759 °
DWR ID	DWR_NA0003_01_s _ 2016_37				
Comment Code					
V6 : Landscaping					
Inspector Comment					
Various overgrown vegetation completely obscuring landside toe visibility.

04/25/2016: Trim trees on L/S slope.

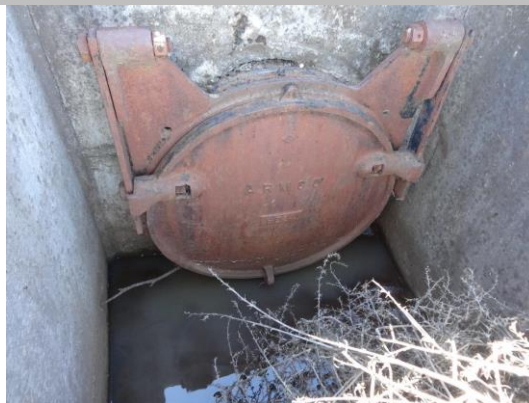
Photo 2 of 3 : UCIP_SP_2017_31667_57967.jpg

WS view: U type concrete headwall, pipe, and flapgate on levee slope. Vegetation debris on outlet box.

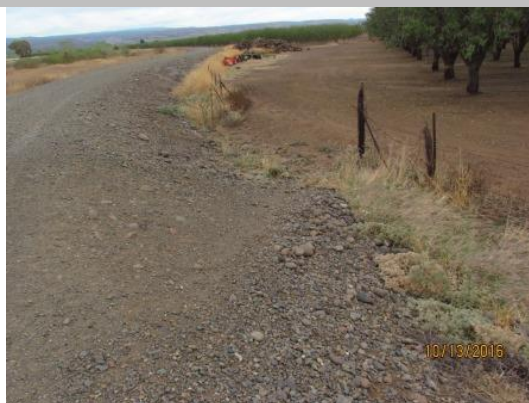
Photo 1 of 1 : SP_2017_NA0003_65_29_20170315_00007.jpg

LM Start	0.31	Rating **	M	Issue No.	29
LM End	0.31	Issue Type +	Ma	Location *	LS
Category	Earthen Levee			GPS Latitude/Longitude	
				Start	End
Item	Slope Stability			39.797071 °	39.797071 °
				-121.883049 °	-121.883049 °
DWR ID	DWR_NA0003_02_f_2016_29				
Comment Code					
S3 : Repair the levee slope damaged by vehicle traffic and prevent access where possible.					
Inspector Comment

View of the slope instability caused by vehicles along the landside slope.

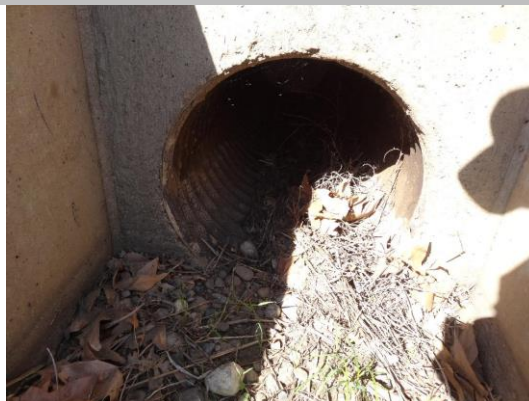
Photo 2 of 3 : UCIP_SP_2017_30403_55921.jpg

LS view: U type concrete headwall and CMP on levee slope. Vegetation debris in inlet pipe.

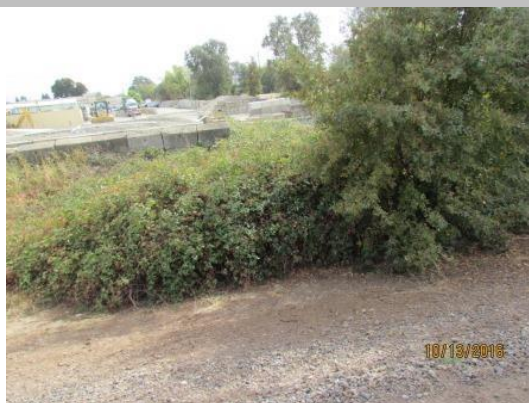
Photo 1 of 1 : SP_2017_NA0003_65_30_20170315_00008.jpg

LM Start	1.45	Rating **	M	Issue No.	30
LM End	1.45	Issue Type +	En	Location *	WS
Category	Earthen Levee			GPS Latitude/Longitude	
				Start	End
Item	Vegetation			39.783084 °	39.783084 °
				-121.887625 °	-121.887625 °
DWR ID	DWR_NA0003_02_f_2016_30				
Comment Code					
V6 : Landscaping					
Inspector Comment					
Blackberry bramble

View of the blackberries blocking visibility and access.

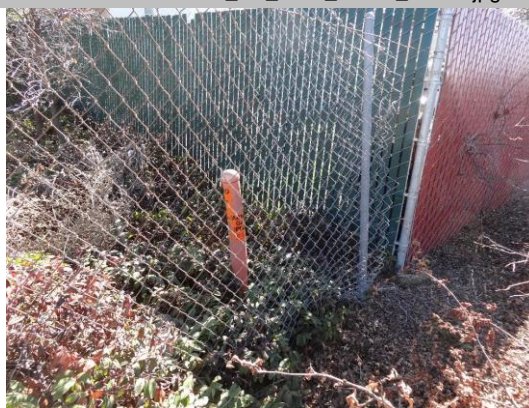
Photo 1 of 1 : UCIP_SP_2017_41873_56643.jpg

LM Start	1.49	Rating **	M	Issue No.	44
LM End	1.49	Issue Type +	En	Location *	LS
Category	Supplemental			GPS Latitude/Longitude	
				Start	End
Item	DWR UCIP Field Study			39.782766 °	39.782766 °
				-121.888187 °	-121.888187 °
DWR ID					
Comment Code					
Inspector Comment					
FS_ID:41873 DS_ID:24803 EP_NO: 9874 Repair Type: Non-Urgent Crossing Status: Indicator Found UCIP Comments: May need to contact owner to determine status of crossing and install markers as appropriate. FIELD_STRUCT_DESC: A 6-inch gas main through both levees and channel of Mud Creek Downstream from old Highway 99E (Esplanade Road Bridge). (Permit No. 9874- PG and E) Indicator on landside toe. FS Date: 2/24/2014

LS view: gasoline marker on levee toe.

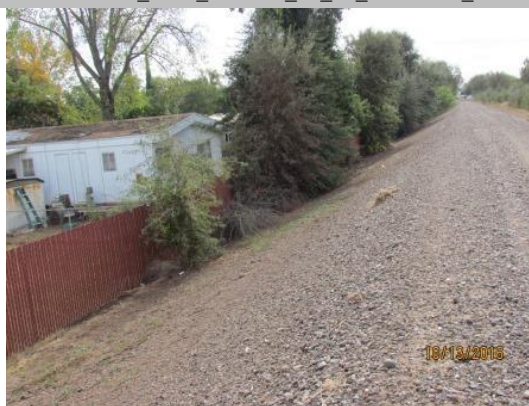
Photo 1 of 1 : SP_2017_NA0003_65_31_20170315_00009.jpg

LM Start	1.54	Rating **	M	Issue No.	31
LM End	1.74	Issue Type +	Ma	Location *	LS
Category	Earthen Levee			GPS Latitude/Longitude	
				Start	End
Item	Trim / Thin Trees			39.782175 °	39.779667 °
				-121.888813 °	-121.890613 °
DWR ID	DWR_NA0003_02_f_2016_31				
Comment Code					
T1 : Trim trees to at least five feet above ground level.					
Inspector Comment

View of the trees along the landside toe.

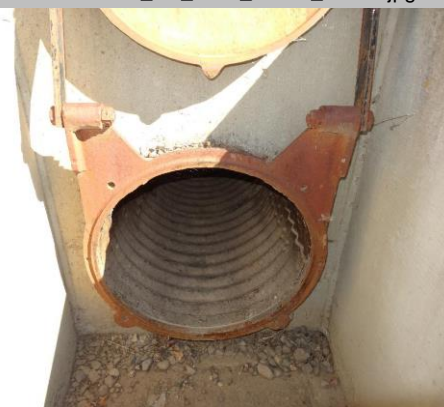
Photo 2 of 3 : UCIP_SP_2017_41375_56645.jpg

WS view: U type concrete headwall, pipe, and flapgate on levee slope.

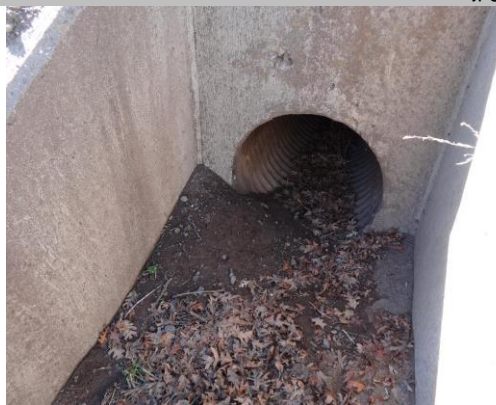
Photo 2 of 3 : UCIP_SP_2017_30783_56681.jpg

LS view: U type concrete headwall and CMP on levee slope. Debris and soil in inlet box.

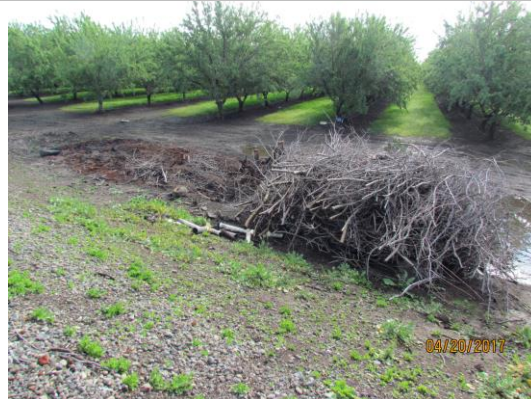
Photo 1 of 2 : SP_2017_NA0003_65_5_20170426_00024.jpg

LM Start	3.31	Rating **	M	Issue No.	5
LM End	3.31	Issue Type +	En	Location *	LS
Category	Earthen Levee			GPS Latitude/Longitude	
				Start	End
Item	Encroachments			39.763208 °	39.763208 °
				-121.908517 °	-121.908517 °
DWR ID	DWR_NA0003_02_f_2012_5				
Comment Code					
PR : Prunings					
Inspector Comment

View of the prunings along the landside toe.

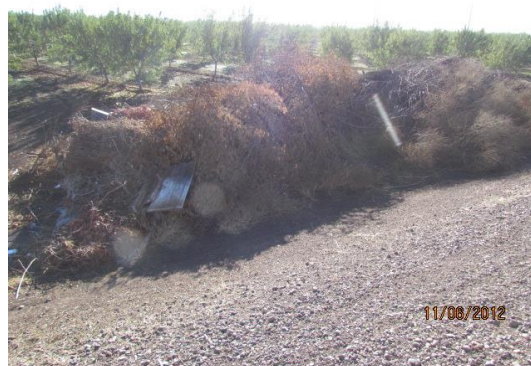
Photo 2 of 2 : SP_2017_NA0003_65_5_20170315_00003.jpg

View of the brush pile along landside toe.

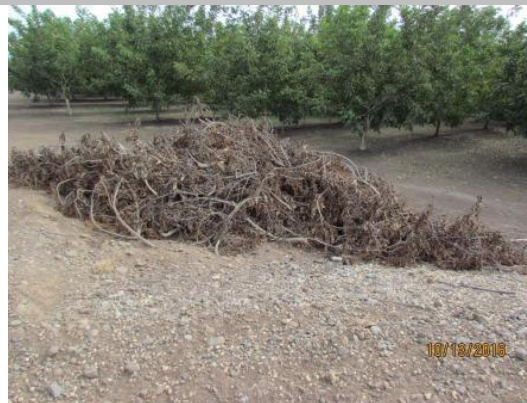
Photo 1 of 1 : SP_2017_NA0003_65_33_20170315_00010.jpg

View of the prunings along the landside toe.

LM Start	3.95	Rating **	M	Issue No.	33
LM End	3.95	Issue Type +	En	Location *	LS
Category	Earthen Levee			GPS Latitude/Longitude	
				Start	End
Item	Encroachments			39.755681 °	39.755681 °
				-121.910628 °	-121.910628 °
DWR ID	DWR_NA0003_02_f_2016_33				
Comment Code					
PR : Prunings					
Inspector Comment					
Remove prunings from the landside toe.

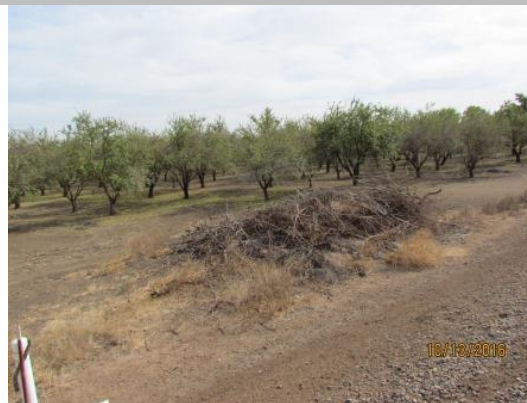
Photo 1 of 1 : SP_2017_NA0003_65_34_20170315_00011.jpg

View of the prunings along the landside toe.

LM Start	4.54	Rating **	M	Issue No.	34
LM End	4.54	Issue Type +	En	Location *	LS
Category	Earthen Levee			GPS Latitude/Longitude	
				Start	End
Item	Encroachments			39.749708 °	39.749708 °
				-121.917162 °	-121.917162 °
DWR ID	DWR_NA0003_02_f_2016_34				
Comment Code					
PR : Prunings					
Inspector Comment					
Remove prunings from the landside toe.

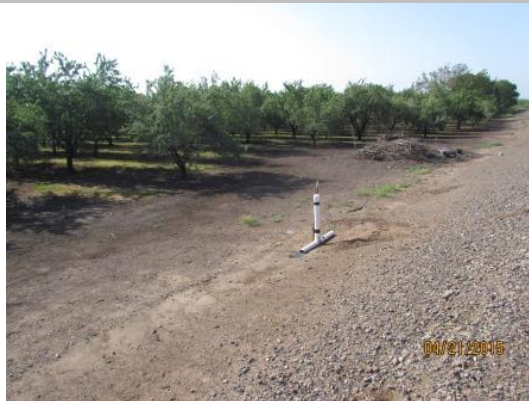
Photo 1 of 2 : SP_2017_NA0003_65_8_20170315_00004.jpg

LM Start	4.55	Rating **	A/W	Issue No.	8 (cont)
LM End	4.55	Issue Type +	Ma	Location *	LS

View of the bait station placed by the rodent hole.

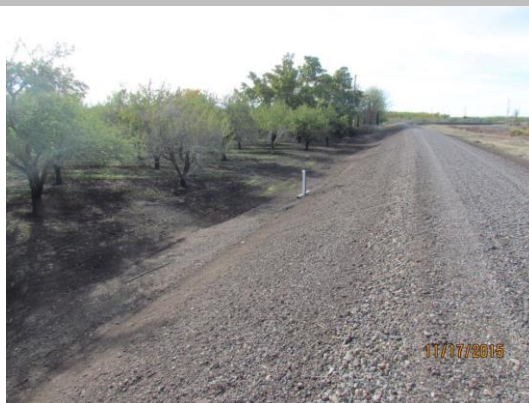
Photo 2 of 2 : SP_2017_NA0003_65_8_20170315_00005.jpg

View of the bait station by the rodent holes.

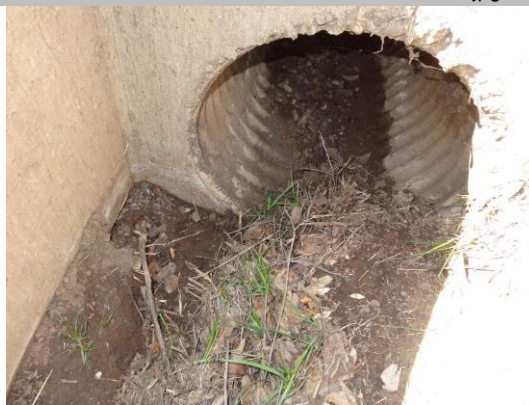
Photo 2 of 3 : UCIP_SP_2017_31028_56912.jpg

LS view: U type concrete headwall and CMP on levee slope.

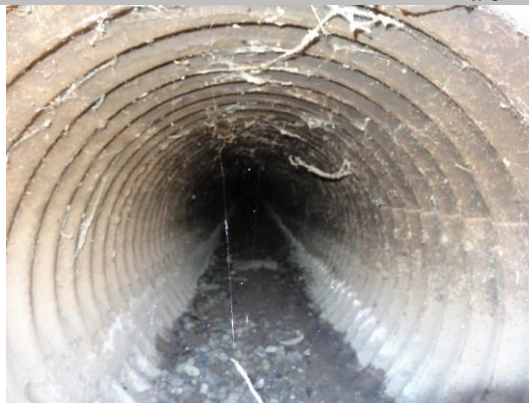
Photo 3 of 3 : UCIP_SP_2017_31028_56911.jpg

LM Start	4.61	Rating **	M	Issue No.	49 (cont)	
LM End	4.61	Issue Type +	Ma	Location *	LS	
Category	Supplemental			GPS Latitude/Longitude		
				Start		End
Item	DWR UCIP LMA Responsibility			39.748731 °		39.748731 °
				-121.917577 °		-121.917577 °
DWR ID						
Comment Code						
Inspector Comment						
FS_ID:31028						
DS_ID:19245						
EP_NO: N/A						
Repair Type: Non-Urgent						
Crossing Status: Found						
UCIP Comments: Needs cleaning and clearing of debris.						
FIELD_STRUCT_DESC: 24-inch CM pipe through the levee, 10.0 feet below the crown. Flap gate on the waterward end. Concrete "U" headwalls on both ends. Grouted riprap apron on the landward end. Grouted riprap spillway on the waterward end. O&M Manual Sac 504, May 1965.						
FS Date: 2/25/2014

LS view: inside view of CMP on levee slope. Needs cleaning and clearing.

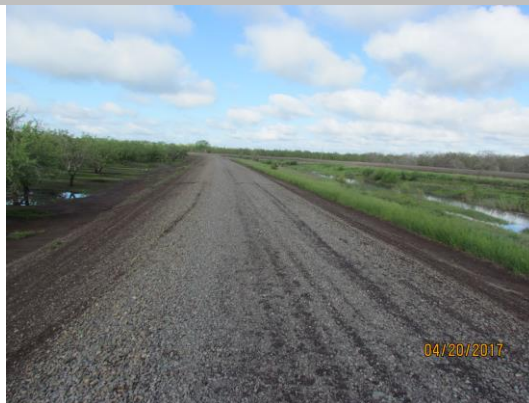
Photo 1 of 1 : SP_2017_NA0003_65_28_20170426_00025.jpg

LM Start	5.56	Rating **	A	Issue No.	28
LM End	5.56	Issue Type +	Ma	Location *	LS
Category	Earthen Levee			GPS Latitude/Longitude	
				Start	End
Item	Vegetation			39.739085 °	39.739085 °
				-121.928878 °	-121.928878 °
DWR ID	DWR_NA0003_02_s_2017_28				
Comment Code					
V1 : Control annual grass and weeds on the levee slopes and easements.					
Inspector Comment

View of no vegetation on both slopes.

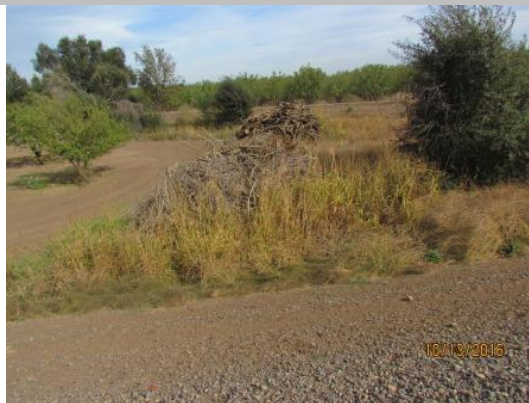
Photo 1 of 1 : SP_2017_NA0003_65_35_20170315_00012.jpg

View of the prunings along the landside toe.

LM Start	6.07	Rating **	M	Issue No.	35
LM End	6.07	Issue Type +	En	Location *	LS
Category	Earthen Levee			GPS Latitude/Longitude	
				Start	End
Item	Encroachments			39.733583 °	39.733583 °
				-121.930511 °	-121.930511 °
DWR ID	DWR_NA0003_02_f_2016_35				
Comment Code					
PR : Prunings					
Inspector Comment					
Remove prunings from the landside toe.

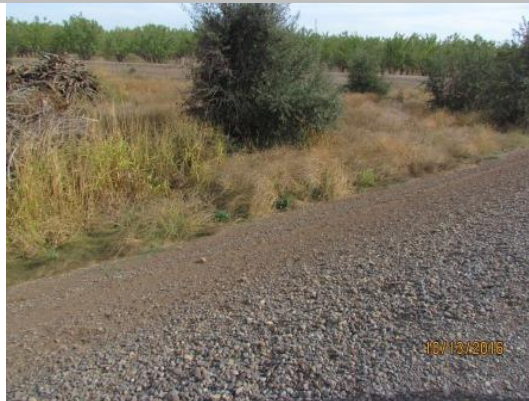
Photo 1 of 1 : SP_2017_NA0003_65_36_20170315_00013.jpg

LM Start	6.08	Rating **	M	Issue No.	36
LM End	6.08	Issue Type +	Ma	Location *	LS
Category	Earthen Levee			GPS Latitude/Longitude	
				Start	End
Item	Vegetation			39.733503 °	39.733503 °
				-121.930481 °	-121.930481 °
DWR ID	DWR_NA0003_02_f_2016_36				
Comment Code					
V1 : Control annual grass and weeds on the levee slopes and easements.					
Inspector Comment

View of the dense vegetation along the landside toe.

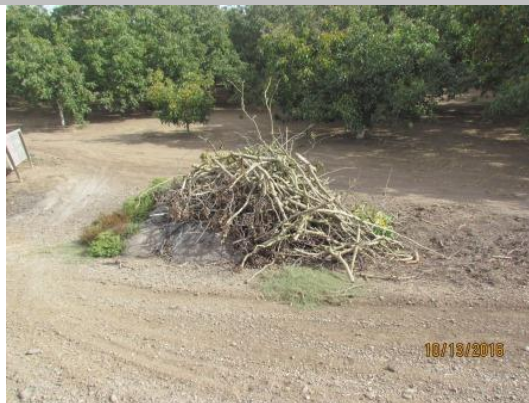
Photo 1 of 1 : SP_2017_NA0003_65_37_20170315_00014.jpg

LM Start	6.44	Rating **	M	Issue No.	37
LM End	6.44	Issue Type +	En	Location *	LS
Category	Earthen Levee			GPS Latitude/Longitude	
				Start	End
Item	Encroachments			39.728779 °	39.728779 °
				-121.932679 °	-121.932679 °
DWR ID	DWR_NA0003_02_f_2016_37				
Comment Code					
PR : Prunings					
Inspector Comment					
Remove prunings from the landside toe.

View of the prunings along the landside toe.

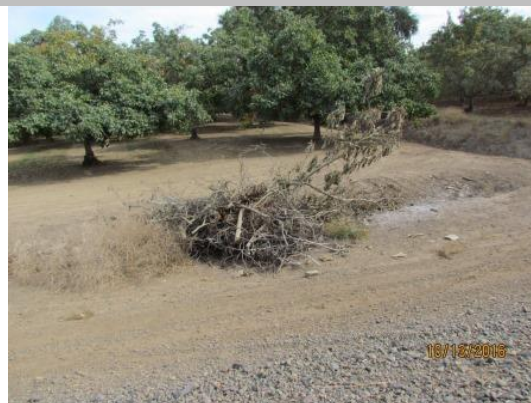
Photo 1 of 1 : SP_2017_NA0003_65_39_20170315_00016.jpg

LM Start	6.92	Rating **	M	Issue No.	39
LM End	6.92	Issue Type +	En	Location *	LS
Category	Earthen Levee			GPS Latitude/Longitude	
				Start	End
Item	Encroachments			39.723014 °	39.723014 °
				-121.937819 °	-121.937819 °
DWR ID	DWR_NA0003_02_f_2016_39				
Comment Code					
PR : Prunings					
Inspector Comment					
Remove prunings from the landside toe.

View of the prunings along the landside toe.

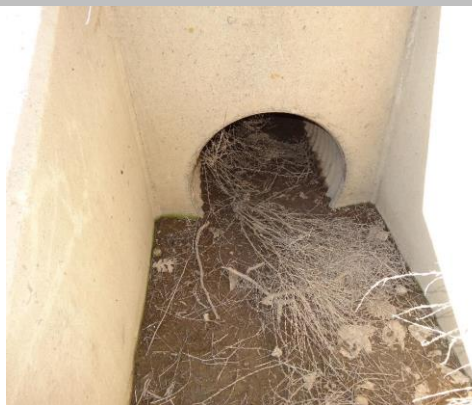
Photo 2 of 3 : UCIP_SP_2017_31103_57001.jpg

LS view: U type concrete headwall and CMP on levee slope. Soil/mud on inlet box.

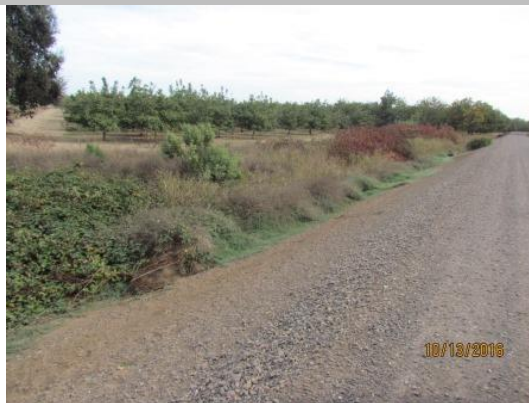
Photo 1 of 1 : SP_2017_NA0003_65_40_20170315_00017.jpg

LM Start	7.17	Rating **	M	Issue No.	40
LM End	7.22	Issue Type +	Ma	Location *	LS
Category	Earthen Levee			GPS Latitude/Longitude	
				Start	End
Item	Vegetation			39.719593 °	39.718933 °
				-121.938137 °	-121.937635 °
DWR ID	DWR_NA0003_02_f_2016_40				
Comment Code					
V2 : Remove the wild growth other than native grasses from the levee slopes.					
Inspector Comment

View of the dense vegetation along the landside toe blocking visibility and access.

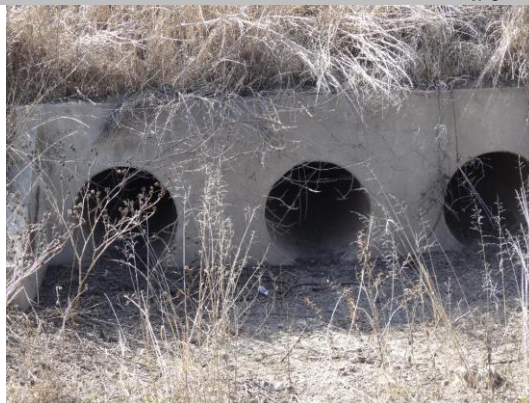
Photo 3 of 3 : UCIP_SP_2017_32085_58586.jpg

LS view: U type concrete headwall and CMPs on levee slope. Soil/mud on inlet box.

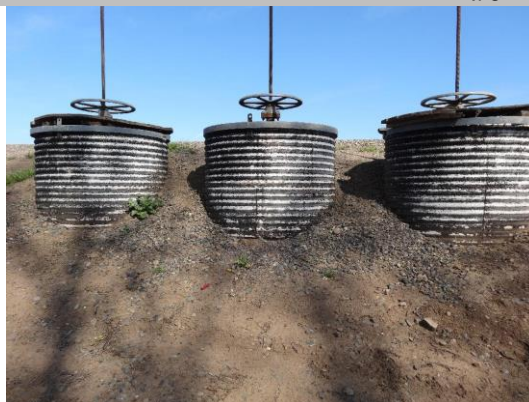
Photo 1 of 3 : UCIP_SP_2017_32087_58592.jpg

LM Start	7.23	Rating **	M	Issue No.	57
LM End	7.23	Issue Type +	Ma	Location *	LS
Category	Supplemental			GPS Latitude/Longitude	
				Start	End
Item	DWR UCIP LMA Responsibility			39.718849 °	39.718849 °
				-121.937580 °	-121.937580 °
DWR ID					
Comment Code					
Inspector Comment					
FS_ID:32087					
DS_ID:19261					
EP_NO: N/A					
Repair Type: Non-Urgent					
Crossing Status: Found					
UCIP Comments: Slide gates in CMP risers on waterside shoulder.Needs cleaning and clearing on both pipe ends.					
FIELD_STRUCT_DESC: 3 of 3: Three 48-inch CM pipes through levee, 18.0 feet below crown Flap gate on the waterward end. Slide gate in CMP riser on waterside shoulder. Concrete "U" headwalls on both ends. Grouted riprap apron on the landward end. Grouted riprap spillway on the waterward end. O&M Manual Sac 504, May 1965.					
FS Date: 2/25/2014

WS view: slide gates in CMP risers on waterside shoulder.

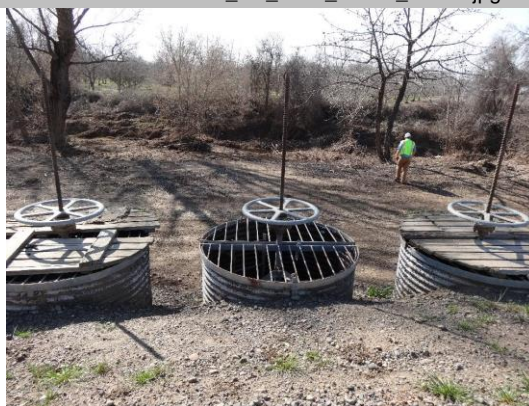
Photo 1 of 3 : UCIP_SP_2017_32086_58589.jpg

LM Start	7.23	Rating **	M	Issue No.	58
LM End	7.23	Issue Type +	Ma	Location *	LS
Category	Supplemental			GPS Latitude/Longitude	
				Start	End
Item	DWR UCIP LMA Responsibility			39.718862 °	39.718862 °
				-121.937594 °	-121.937594 °
DWR ID					
Comment Code					
Inspector Comment					
FS_ID:32086					
DS_ID:19260					
EP_NO: N/A					
Repair Type: Non-Urgent					
Crossing Status: Found					
UCIP Comments: Slide gates in CMP risers on waterside shoulder.Needs cleaning and clearing of debris.					
FIELD_STRUCT_DESC: 2 of 3: Three 48-inch CM pipes through levee, 18.0 feet below crown Flap gate on the waterward end. Concrete "U" headwalls on both ends. Grouted riprap apron on the landward end. Grouted riprap spillway on the waterward end. O&M Manual Sac 504, May 1965.					
FS Date: 2/25/2014

WS view: slide gates in CMP risers on waterside shoulder.

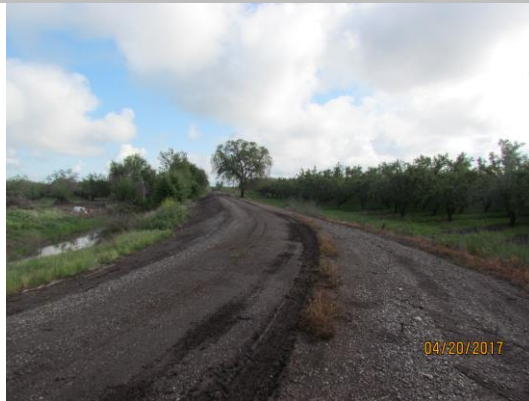
Photo 1 of 1 : SP_2017_NA0003_66_3_20170426_00001.jpg

LM Start	0.01	Rating **	A	Issue No.	3
LM End	0.01	Issue Type +	Ma	Location *	LS
Category	Earthen Levee			GPS Latitude/Longitude	
				Start	End
Item	Vegetation			39.733098 °	39.733098 °
				-121.930138 °	-121.930138 °
DWR ID	DWR_NA0003_02A_s _ 2017_3				
Comment Code					
V1 : Control annual grass and weeds on the levee slopes and easements.					
Inspector Comment

View of no vegetation on both slopes.

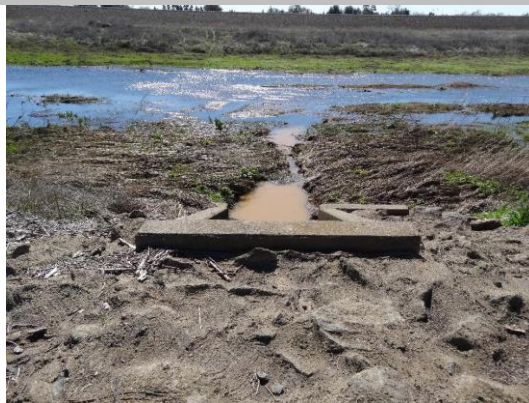
Photo 2 of 3 : UCIP_SP_2017_51844_58601.jpg

WS view: U type concrete headwall of CMP culvert on levee slope. Grouted riprap levee slope and spillway.

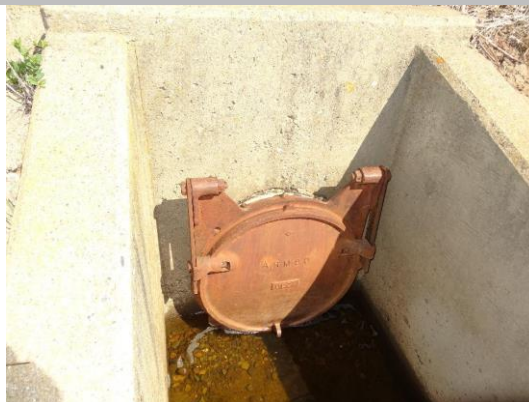
Photo 2 of 3 : UCIP_SP_2017_32107_58612.jpg

WS view: U type concrete headwall, flapgate, and CMP on levee slope.

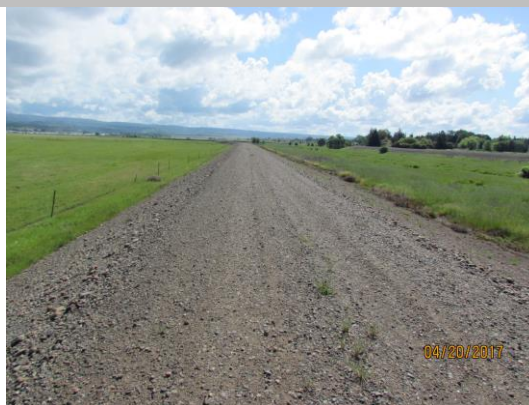
Photo 1 of 1 : SP_2017_NA0003_67_22_20170426_00038.jpg

LM Start	1.35	Rating **	A	Issue No.	22
LM End	1.35	Issue Type +	Ma	Location *	LS
Category	Earthen Levee			GPS Latitude/Longitude	
				Start	End
Item	Vegetation			39.779442 °	39.779442 °
				-121.860913 °	-121.860913 °
DWR ID	DWR_NA0003_03_s_2017_22				
Comment Code					
V1 : Control annual grass and weeds on the levee slopes and easements.					
Inspector Comment

View of no vegetation on both slopes.

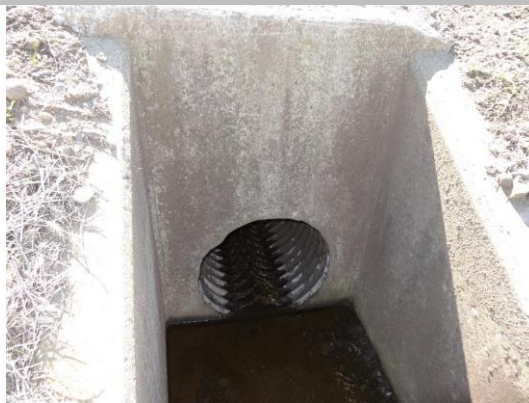
Photo 2 of 2 : UCIP_SP_2017_31899_58186.jpg

LS view: U type concrete headwall and CMP on levee slope. Looks clean and clear.

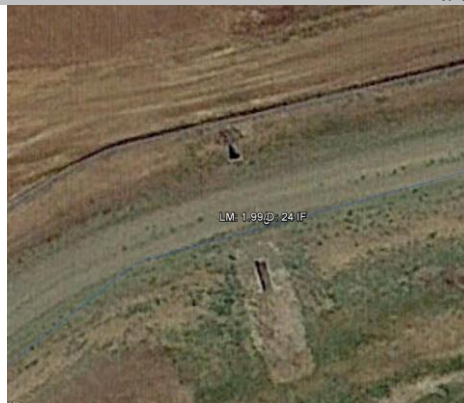
Photo 1 of 1 : UCIP_SP_2017_31900_58189.jpg

LM Start	1.96	Rating **	M	Issue No.	29
LM End	1.96	Issue Type +	En	Location *	LS
Category	Supplemental			GPS Latitude/Longitude	
				Start	End
Item	DWR UCIP Field Study			39.781714 °	39.781714 °
				-121.850868 °	-121.850868 °
DWR ID					
Comment Code					
Inspector Comment					
FS_ID:31900 DS_ID:19266 EP_NO: N/A Repair Type: Non-Urgent Crossing Status: Indicator Found UCIP Comments: Needs location confirmation, GPS reading has not taken due to access problem. FIELD_STRUCT_DESC: 24-inch CM pipe through the levee, 8.0 feet below the crown. Flap gate on the waterward end. Concrete "U" headwalls on both ends. Grouted riprap apron on the landward end. Grouted riprap spillway on the waterward end. O&M Manual Sac 504, May 1965. FS Date: 3/11/2014

Bird's eye view: concrete headwall visible on both sides of the levee.
Grouted riprap spillway on waterside.

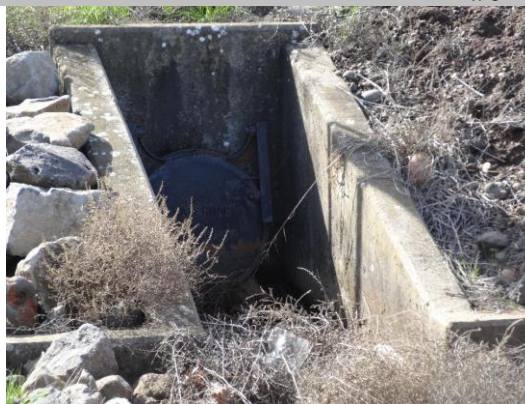
Photo 1 of 3 : UCIP_SP_2017_32124_58625.jpg

LM Start	2.17	Rating **	M	Issue No.	30
LM End	2.17	Issue Type +	Ma	Location *	LS
Category	Supplemental			GPS Latitude/Longitude	
				Start	End
Item	DWR UCIP LMA Responsibility			39.785290 °	39.785290 °
				-121.844235 °	-121.844235 °
DWR ID					
Comment Code					
Inspector Comment					
FS_ID:32124					
DS_ID:19267					
EP_NO: N/A					
Repair Type: Non-Urgent					
Crossing Status: Found					
UCIP Comments: Pipe is about 4 feet below the crown. Needs cleaning and clearing the culvert.					
FIELD_STRUCT_DESC: 24-inch CM pipe through the levee, 6.0 feet below the crown. Flap gate on the waterward end. Concrete "U" headwall on each end. O&M Manual Sac 504, May 1965.					
FS Date: 3/7/2014

WS view: concrete headwall, pipe, and flapgate on levee slope.
Vegetation and mud on outlet box.

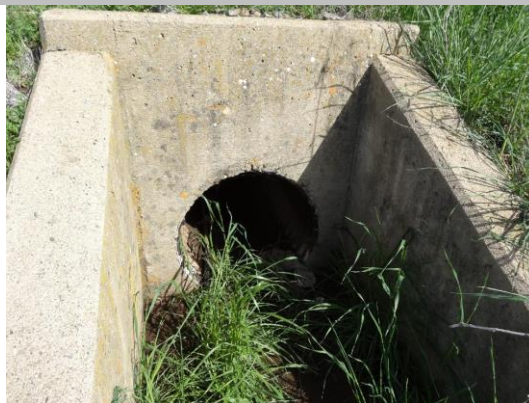
Photo 3 of 3 : UCIP_SP_2017_32124_58627.jpg

LS view: inside view of CMP on levee slope. Needs cleaning and clearing.

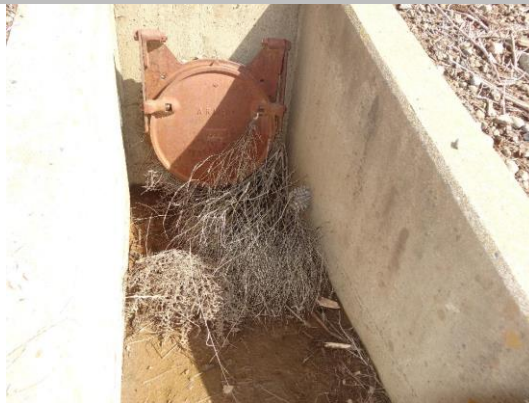
Photo 1 of 3 : UCIP_SP_2017_31901_58194.jpg

LM Start	3.08	Rating **	M	Issue No.	32					
LM End	3.08	Issue Type +	Ma	Location *	LS					
Category	Supplemental		GPS Latitude/Longitude							
			Start	End						
Item	DWR UCIP LMA Responsibility		39.778016 °	39.778016 °						
			-121.854460 °	-121.854460 °						
DWR ID										
Comment Code										
Inspector Comment										
FS_ID:31901 DS_ID:19269 EP_NO: N/A Repair Type: Non-Urgent Crossing Status: Found UCIP Comments: Needs cleaning and clearing the culvert. FIELD_STRUCT_DESC: 24-inch CM pipe through the levee, 11.0 feet below the crown. Flap gate on the waterward end. Concrete "U" headwalls on both ends. Grouted riprap apron on the landward end. Grouted riprap spillway on the waterward end. O&M Manual Sac 504, May 1965. FS Date: 3/7/2014

WS view: U type concrete headwall, flapgate, and CMP on levee slope.
Needs cleaning and clearing.

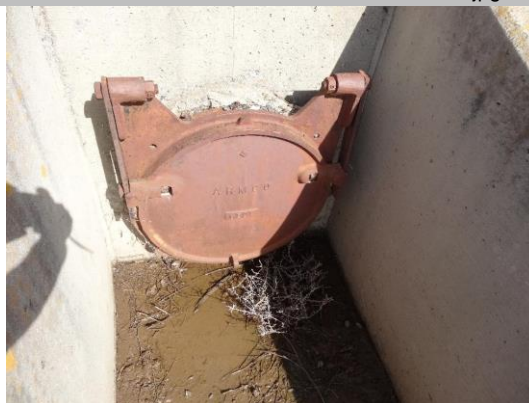
Photo 2 of 3 : UCIP_SP_2017_31902_58200.jpg

WS view: U type concrete headwall and CMP on levee slope.

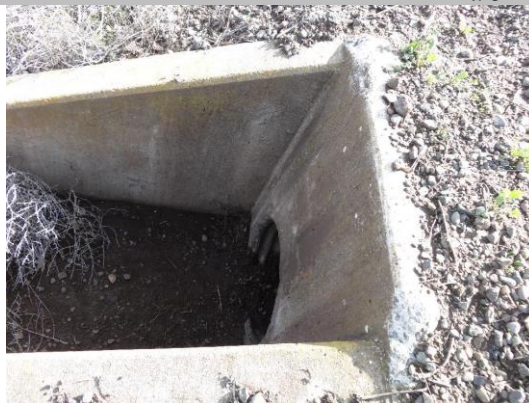
Photo 3 of 3 : UCIP_SP_2017_31902_58199.jpg

LS view: U type concrete headwall and CMP on levee slope. Soil/mud on inlet box.

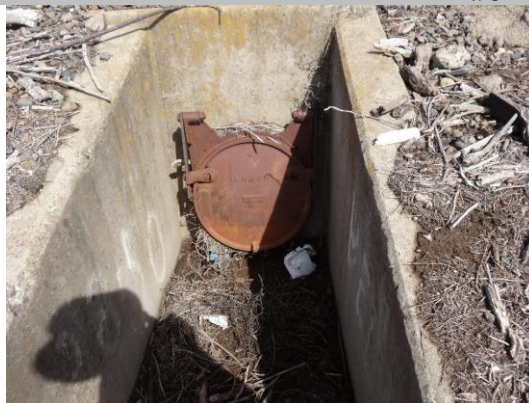
Photo 1 of 3 : UCIP_SP_2017_31864_58069.jpg

LM Start	3.34	Rating **	M	Issue No.	34
LM End	3.34	Issue Type +	Ma	Location *	LS
Category	Supplemental			GPS Latitude/Longitude	
				Start	End
Item	DWR UCIP LMA Responsibility			39.777410 °	39.777410 °
				-121.849627 °	-121.849627 °
DWR ID					
Comment Code					
Inspector Comment					
FS_ID:31864					
DS_ID:19271					
EP_NO: N/A					
Repair Type: Non-Urgent					
Crossing Status: Found					
UCIP Comments: Needs cleaning and clearing the culvert.					
FIELD_STRUCT_DESC: 24-inch CM pipe through the levee, 10.5 feet below the crown. Flap gate on the waterward end. Concrete "U" headwalls on both ends. Grouted riprap apron on the landward end. Grouted riprap spillway on the waterward end. O&M Manual Sac 504, May 1965.					
FS Date: 3/7/2014

WS view: U type concrete headwall, pipe, and flapgate on levee slope. Soil/mud on outlet box. Vegetation debris blocking outlet box.

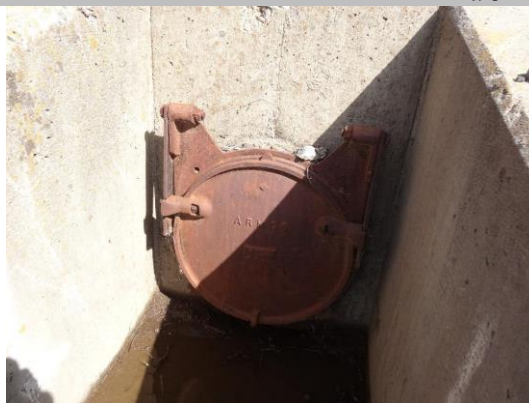
Photo 1 of 3 : UCIP_SP_2017_31856_58053.jpg

LM Start	3.50	Rating **	M	Issue No.	35
LM End	3.50	Issue Type +	Ma	Location *	LS
Category	Supplemental			GPS Latitude/Longitude	
				Start	End
Item	DWR UCIP LMA Responsibility			39.777139 °	39.777139 °
				-121.846769 °	-121.846769 °
DWR ID					
Comment Code					
Inspector Comment					
FS_ID:31856 DS_ID:19272 EP_NO: N/A Repair Type: Non-Urgent Crossing Status: Found UCIP Comments: Needs cleaning and clearing the culvert. FIELD_STRUCT_DESC: 24-inch CM pipe through the levee, 9.5 feet below the crown. Flap gate on the waterward end. Concrete "U" headwalls on both ends. Grouted riprap apron on the landward end. Grouted riprap spillway on the waterward end. O&M Manual Sac 504, May 1965. FS Date: 3/7/2014

WS view: U type concrete headwall, pipe, and flapgate on levee slope.
Soil/mud on outlet box.

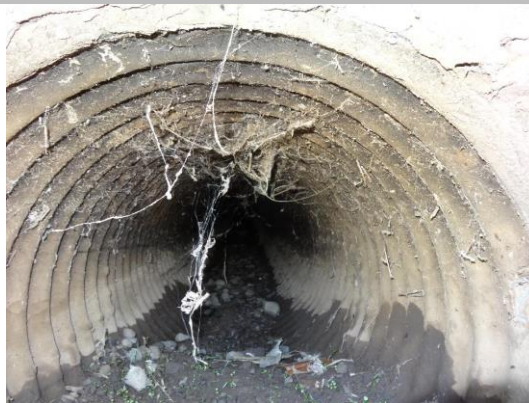
Photo 3 of 3 : UCIP_SP_2017_31856_58051.jpg

LS view: inside view of CMP on levee slope. Needs cleaning and clearing.
